# Pre-Construction Road Safety Audit

Northgate Drive and State Road 43 Intersection  
Area Plan Commission of Tippecanoe County  
January 2017

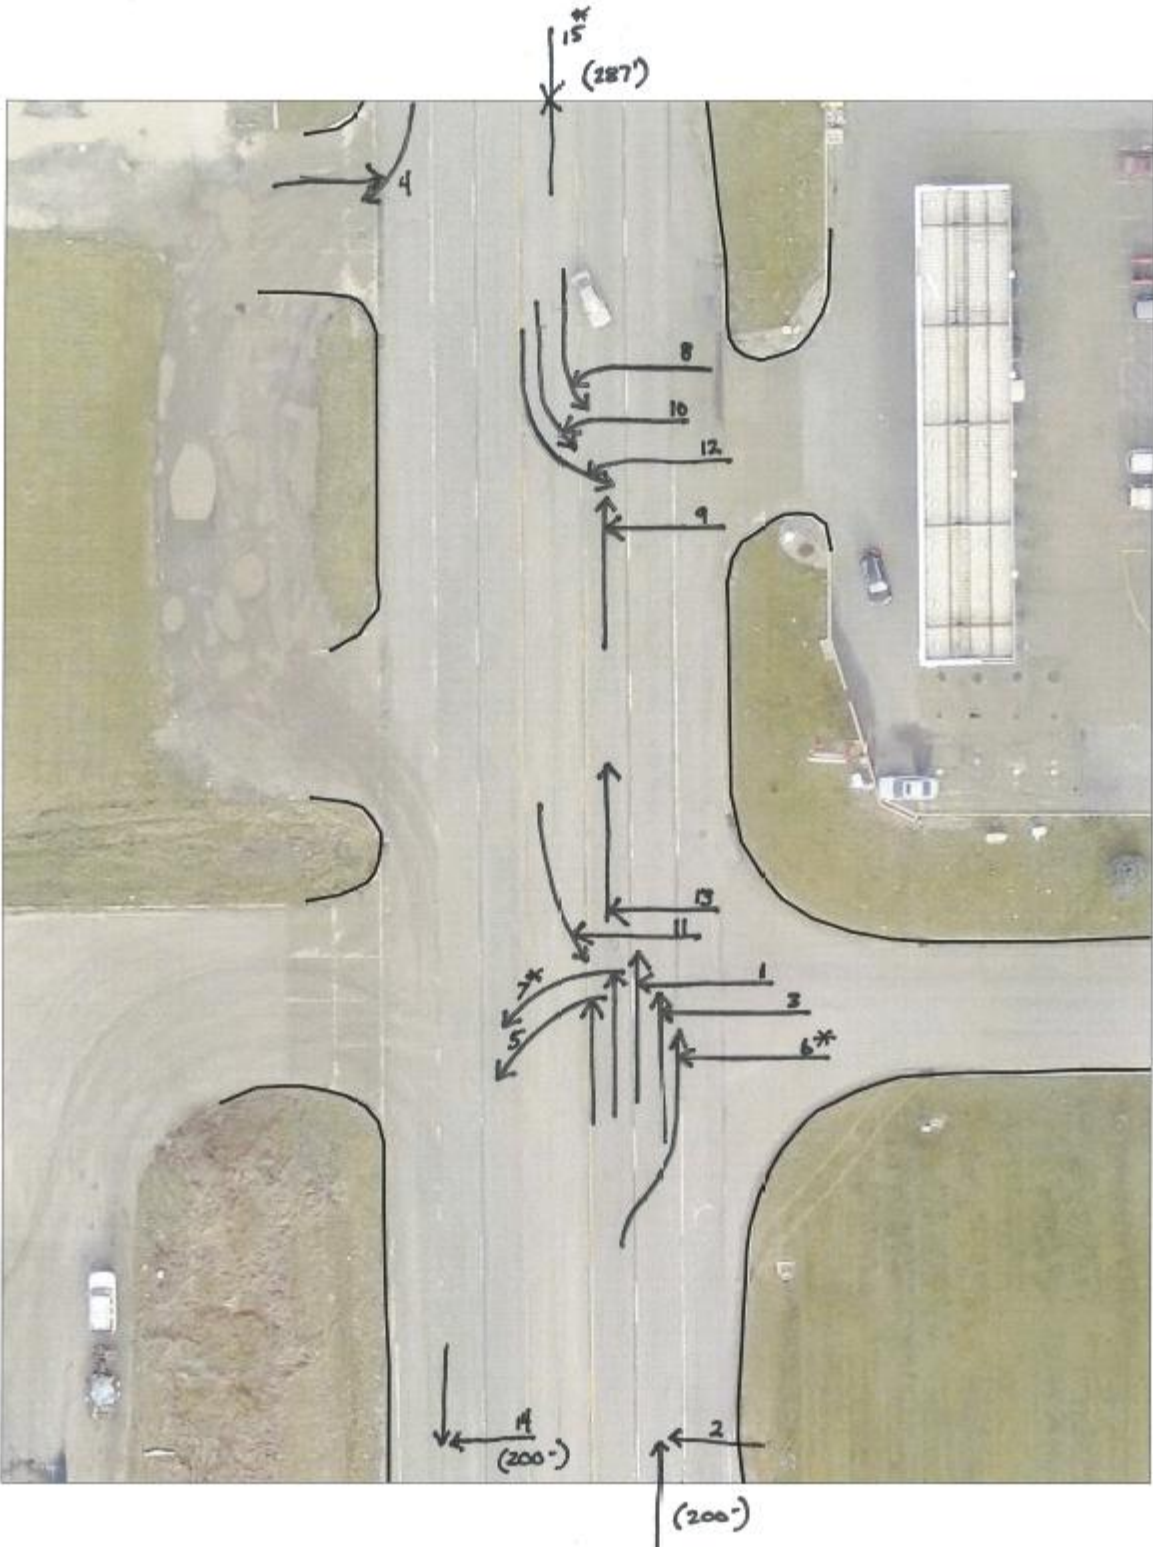
Crash Diagram

Of the different types of crashes reported, six of them (40%) were right angle collisions and three (20%) were left turn collisions. Additionally, two (13.3%) were classified as left/right turn collisions. The crash reports also showed that there was one each of the following manners of collision: collision with deer, head on, head on between two motor vehicles, and other-explain in narrative.

There were four different primary factors in the crash reports. The most common primary factor was failure to yield right of way with eleven crashes (73.3%). There were two crashes where the primary factor was listed as animal in the roadway, one where the primary factor was listed as other (driver), and one where the primary factor was listed as other (environmental).

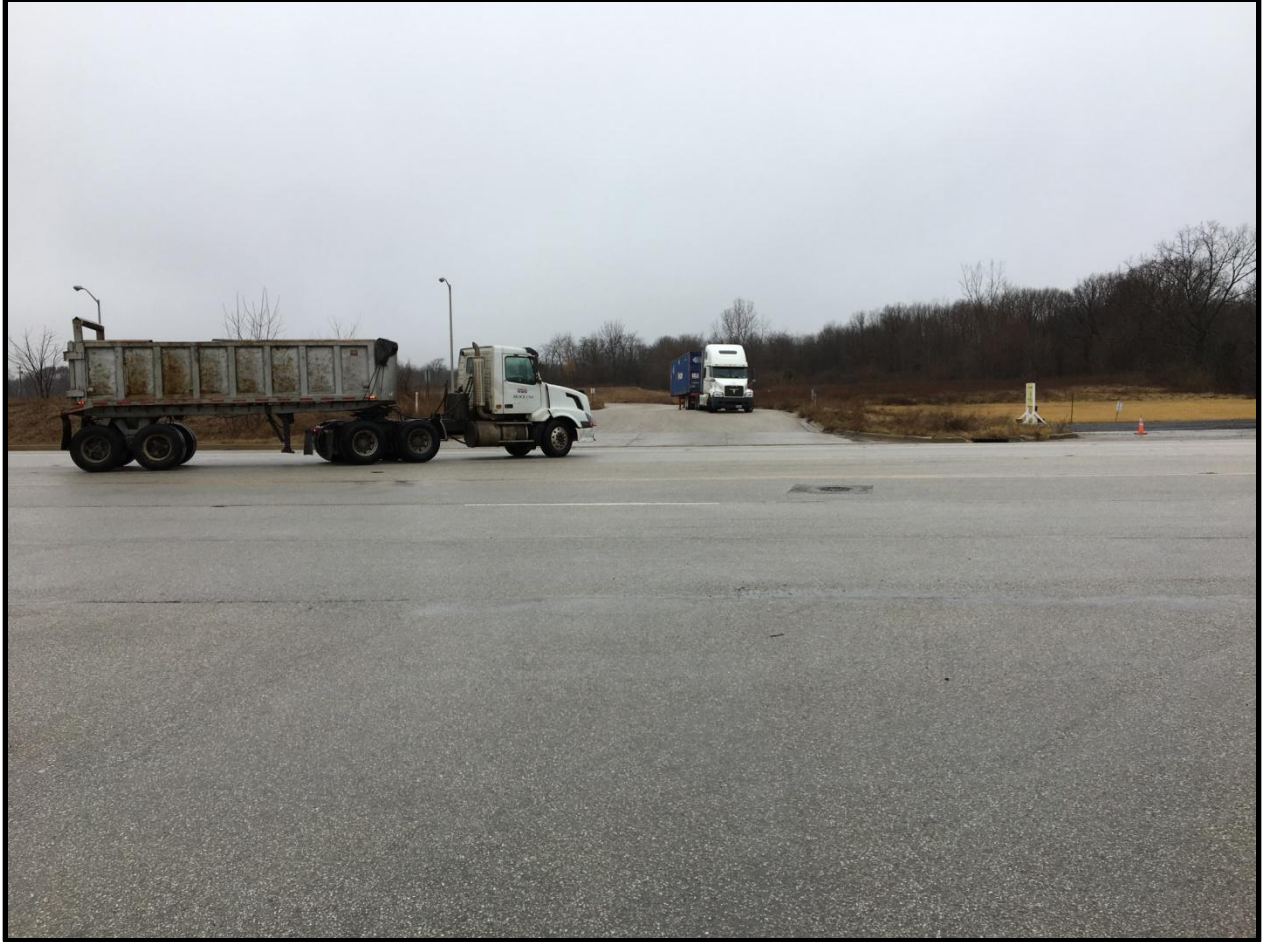
On Northgate Drive, looking west at truck turning left off of State Road 43

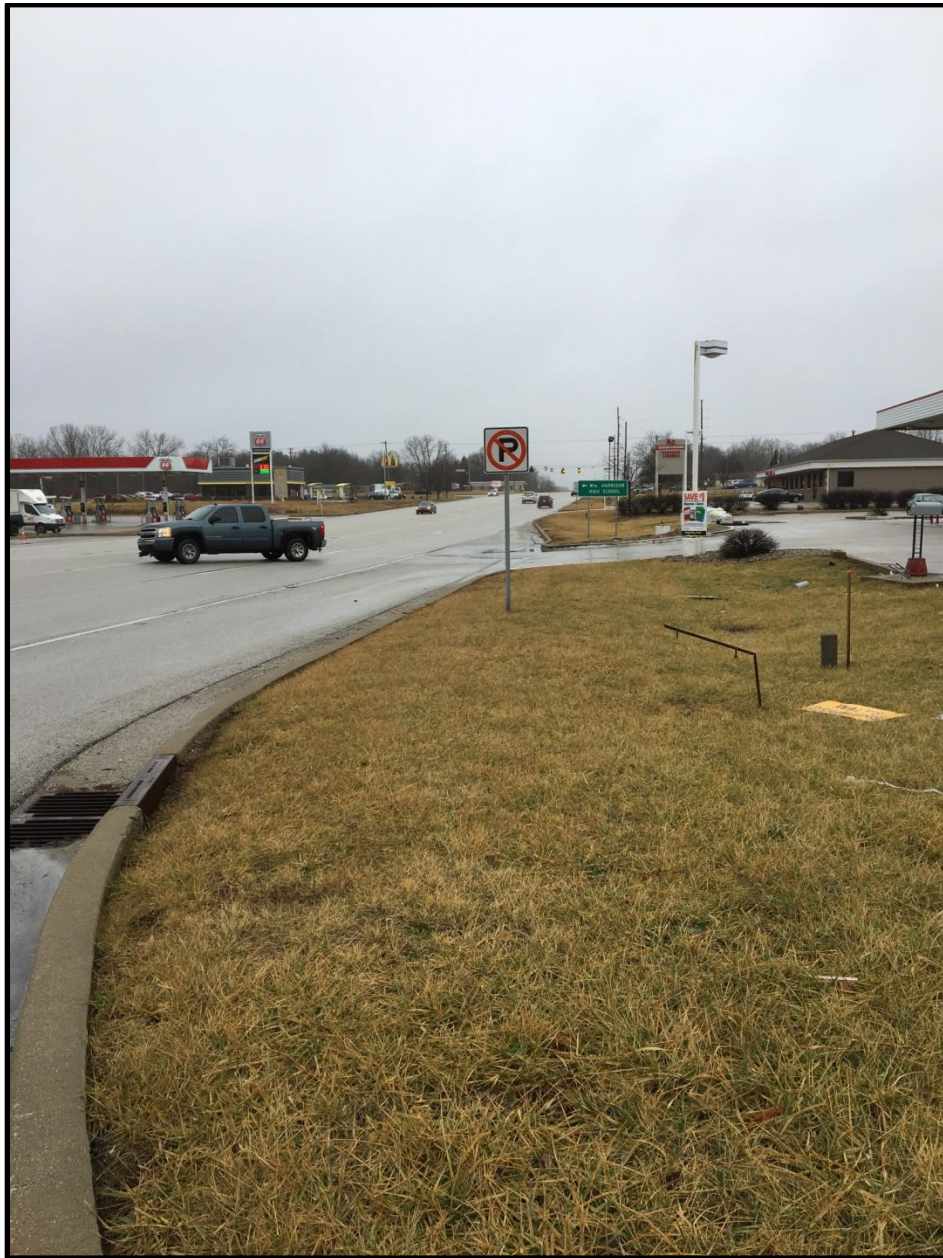
Vehicle turning left (southbound) on State Road 43 from Speedway gas station
